U.S. Department  
of Transportation

National Highway  
Traffic Safety  
Administration

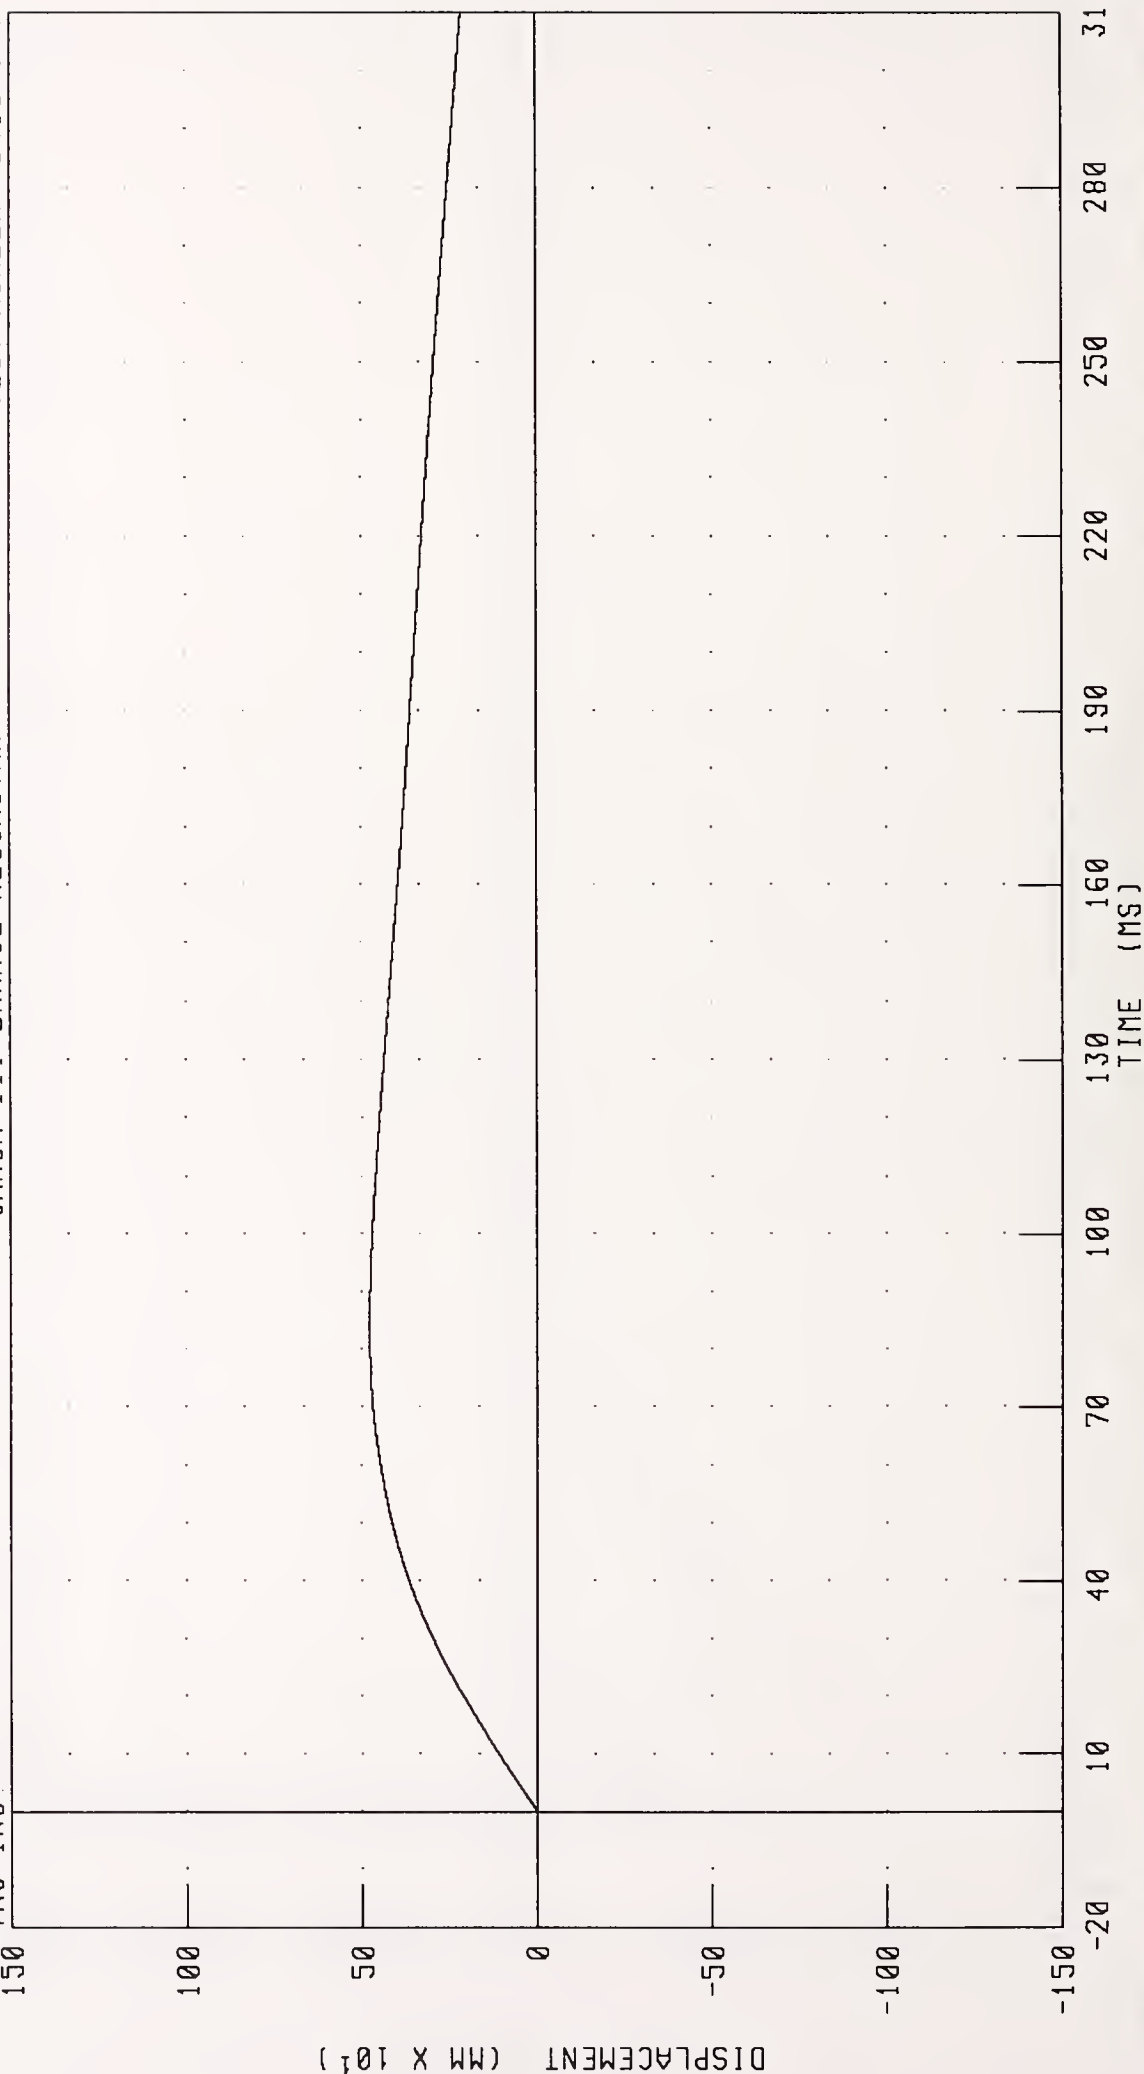
CHANNEL: RRSXD1 FILTER: CH. CLASS 180 PEAK DATA: 477.72 MM @ 84.00 MS; 0.00 MM @ 0.00 MS

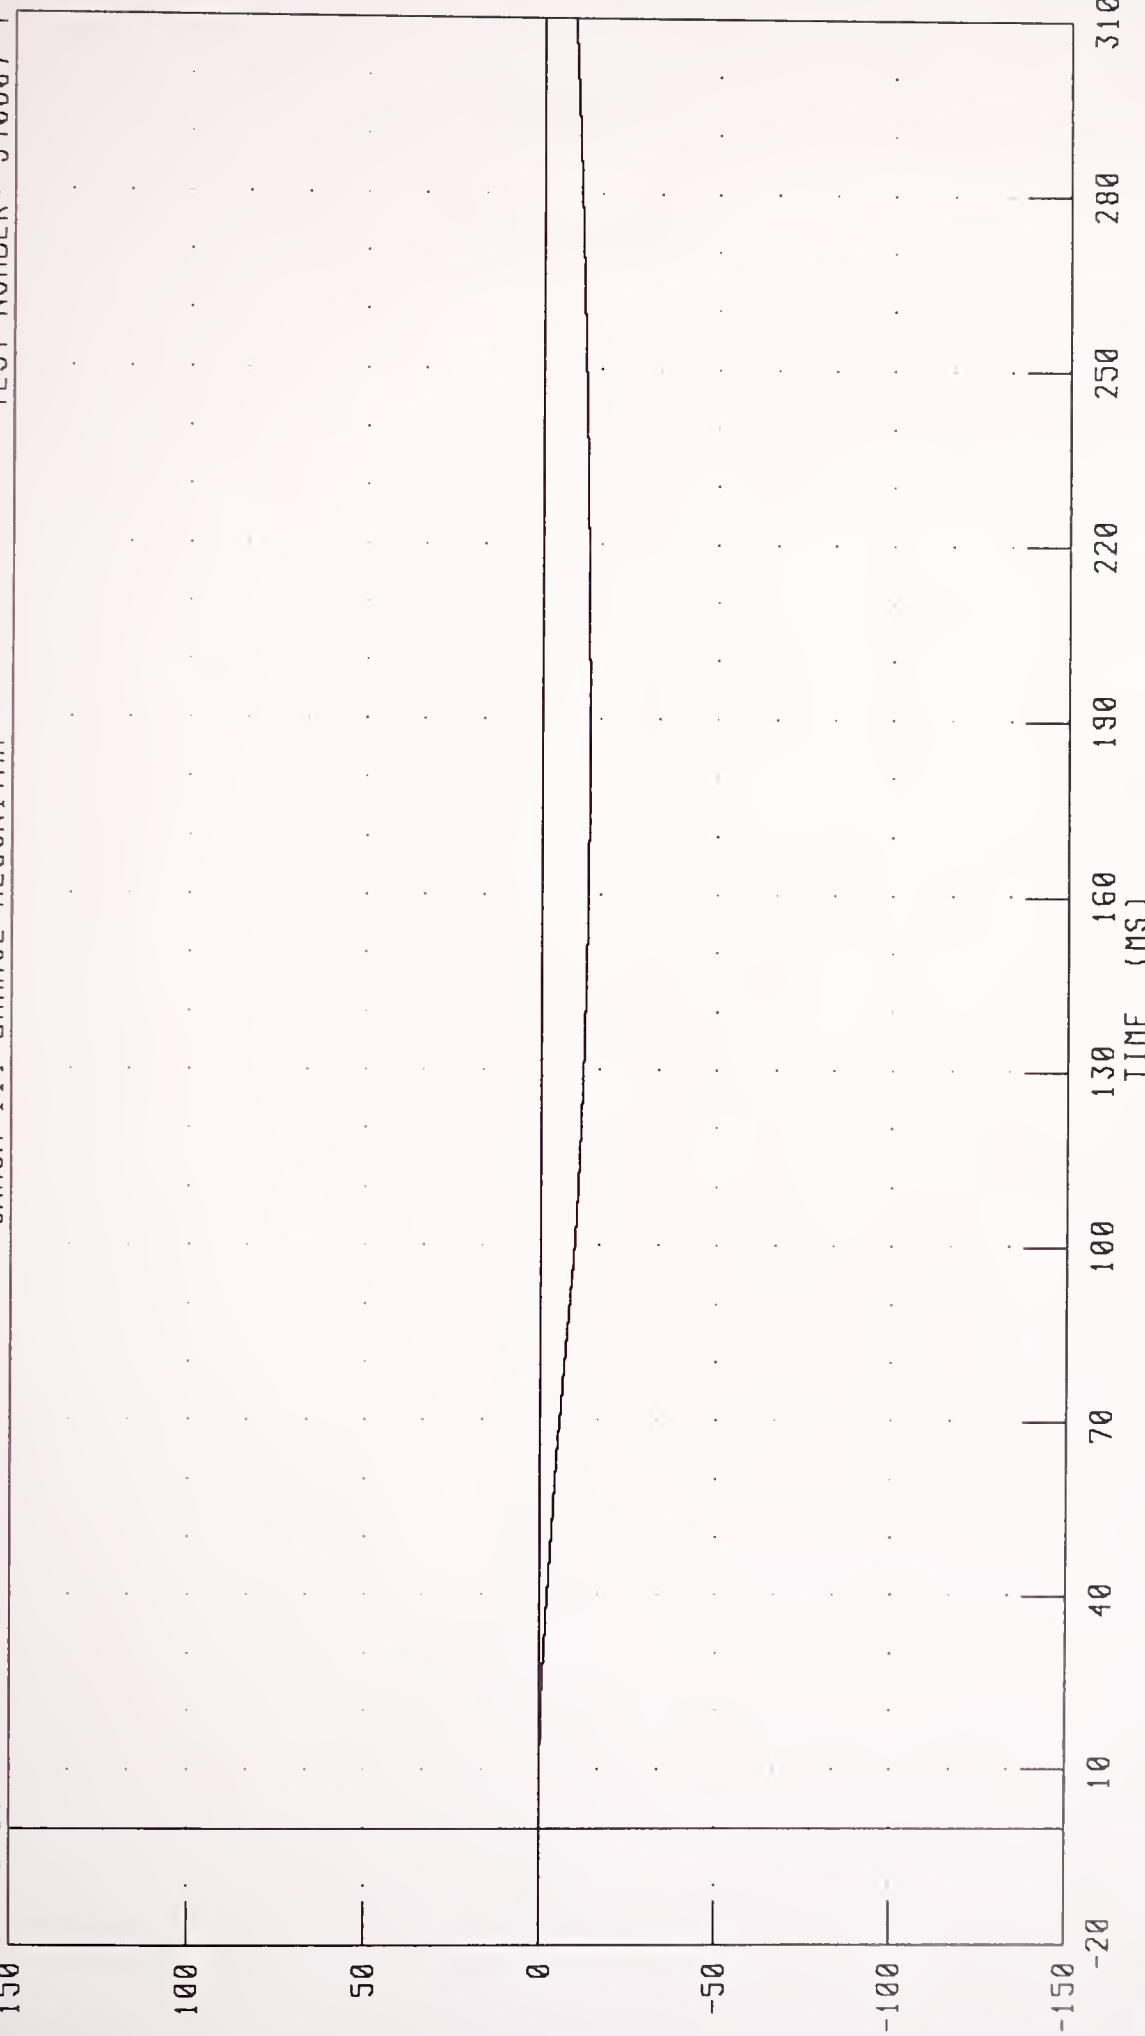
CHANNEL: RRSYD1 FILTER: CH. CLASS 180 PEAK DATA: 0.00 MM @ 0.00 MS; -134.05 MM @ 184.72 MS

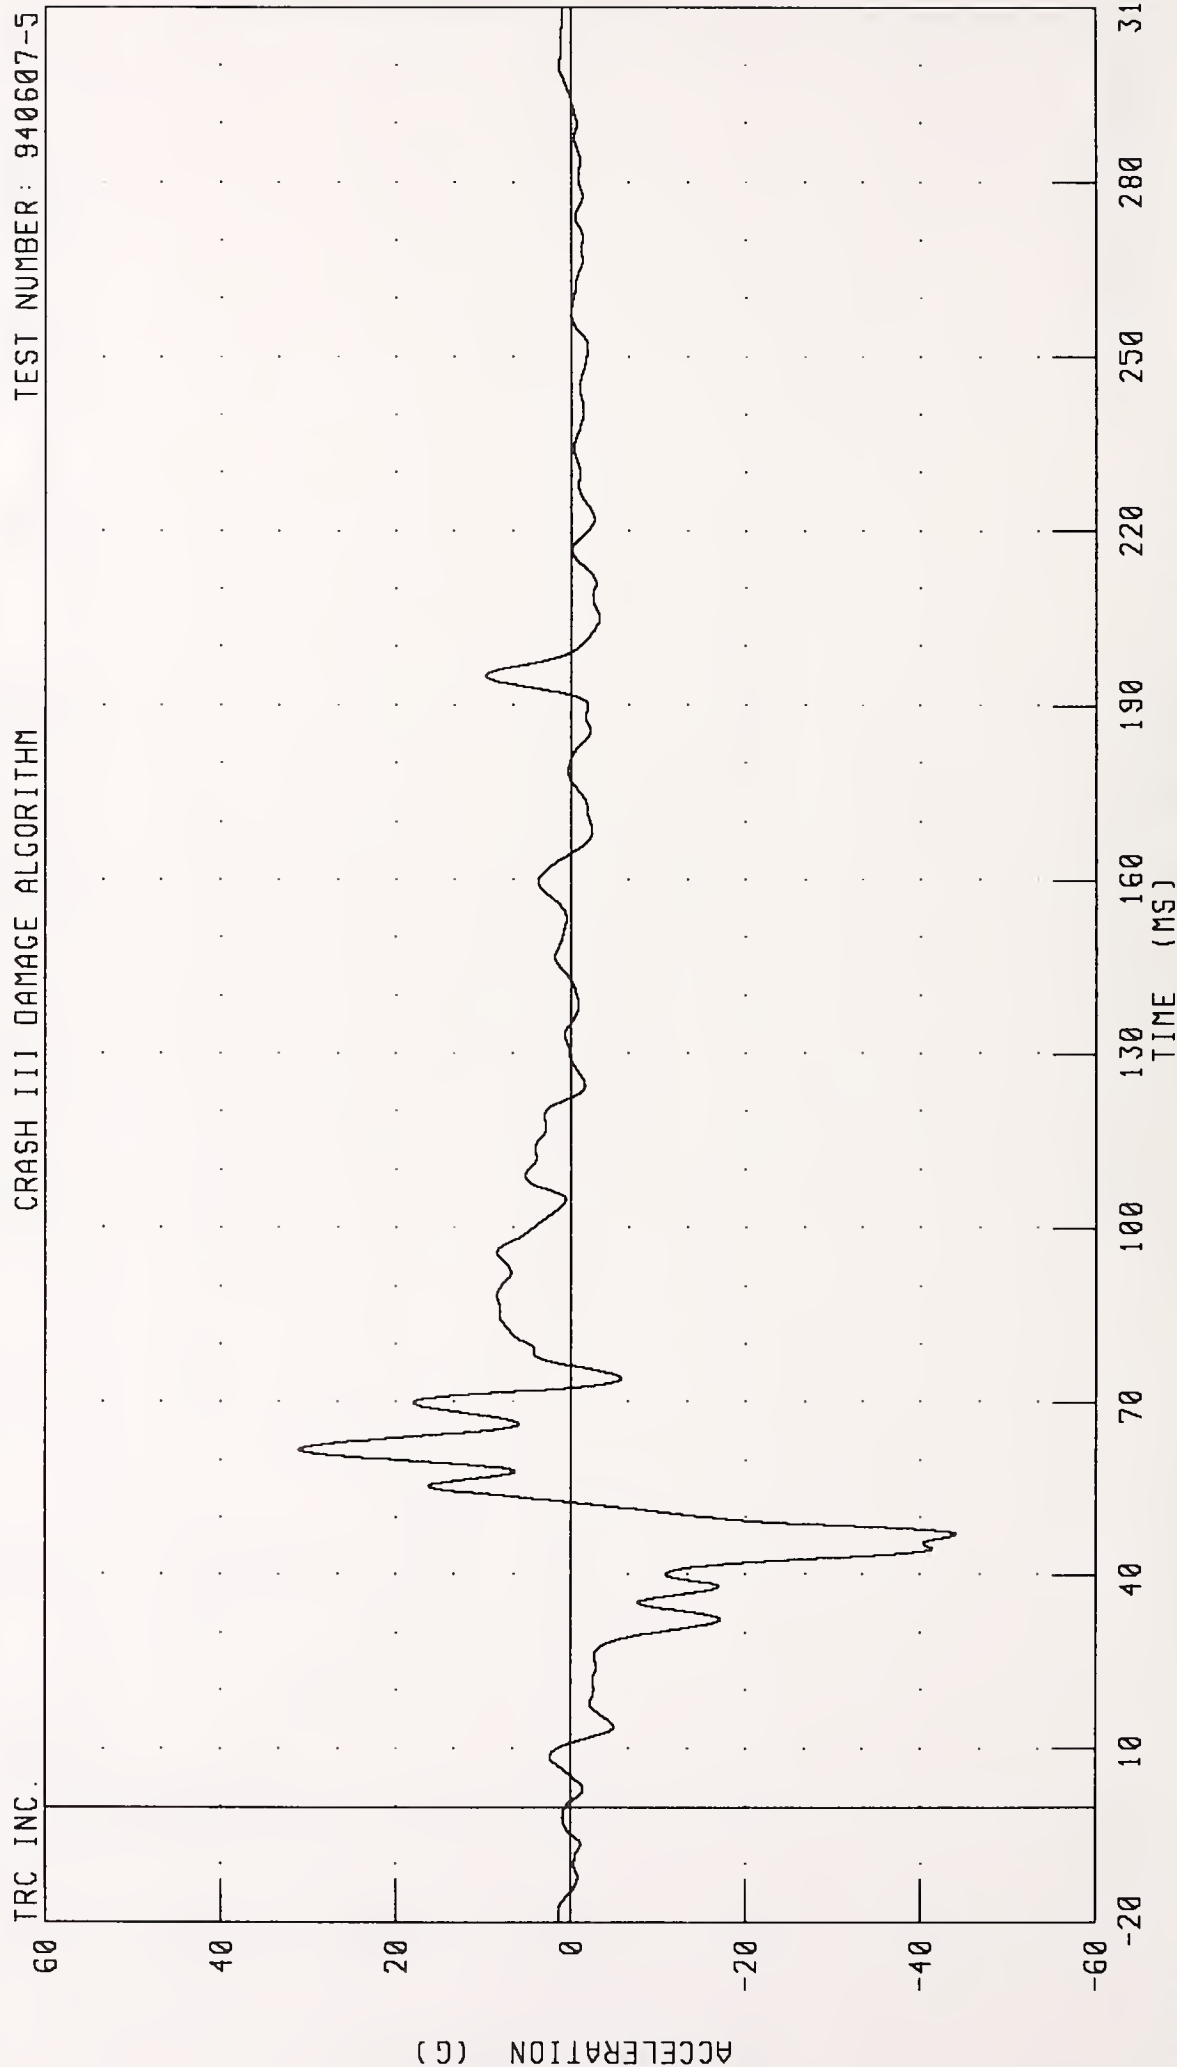
CHANNEL: VCCYG1 FILTER: CH. CLASS 60

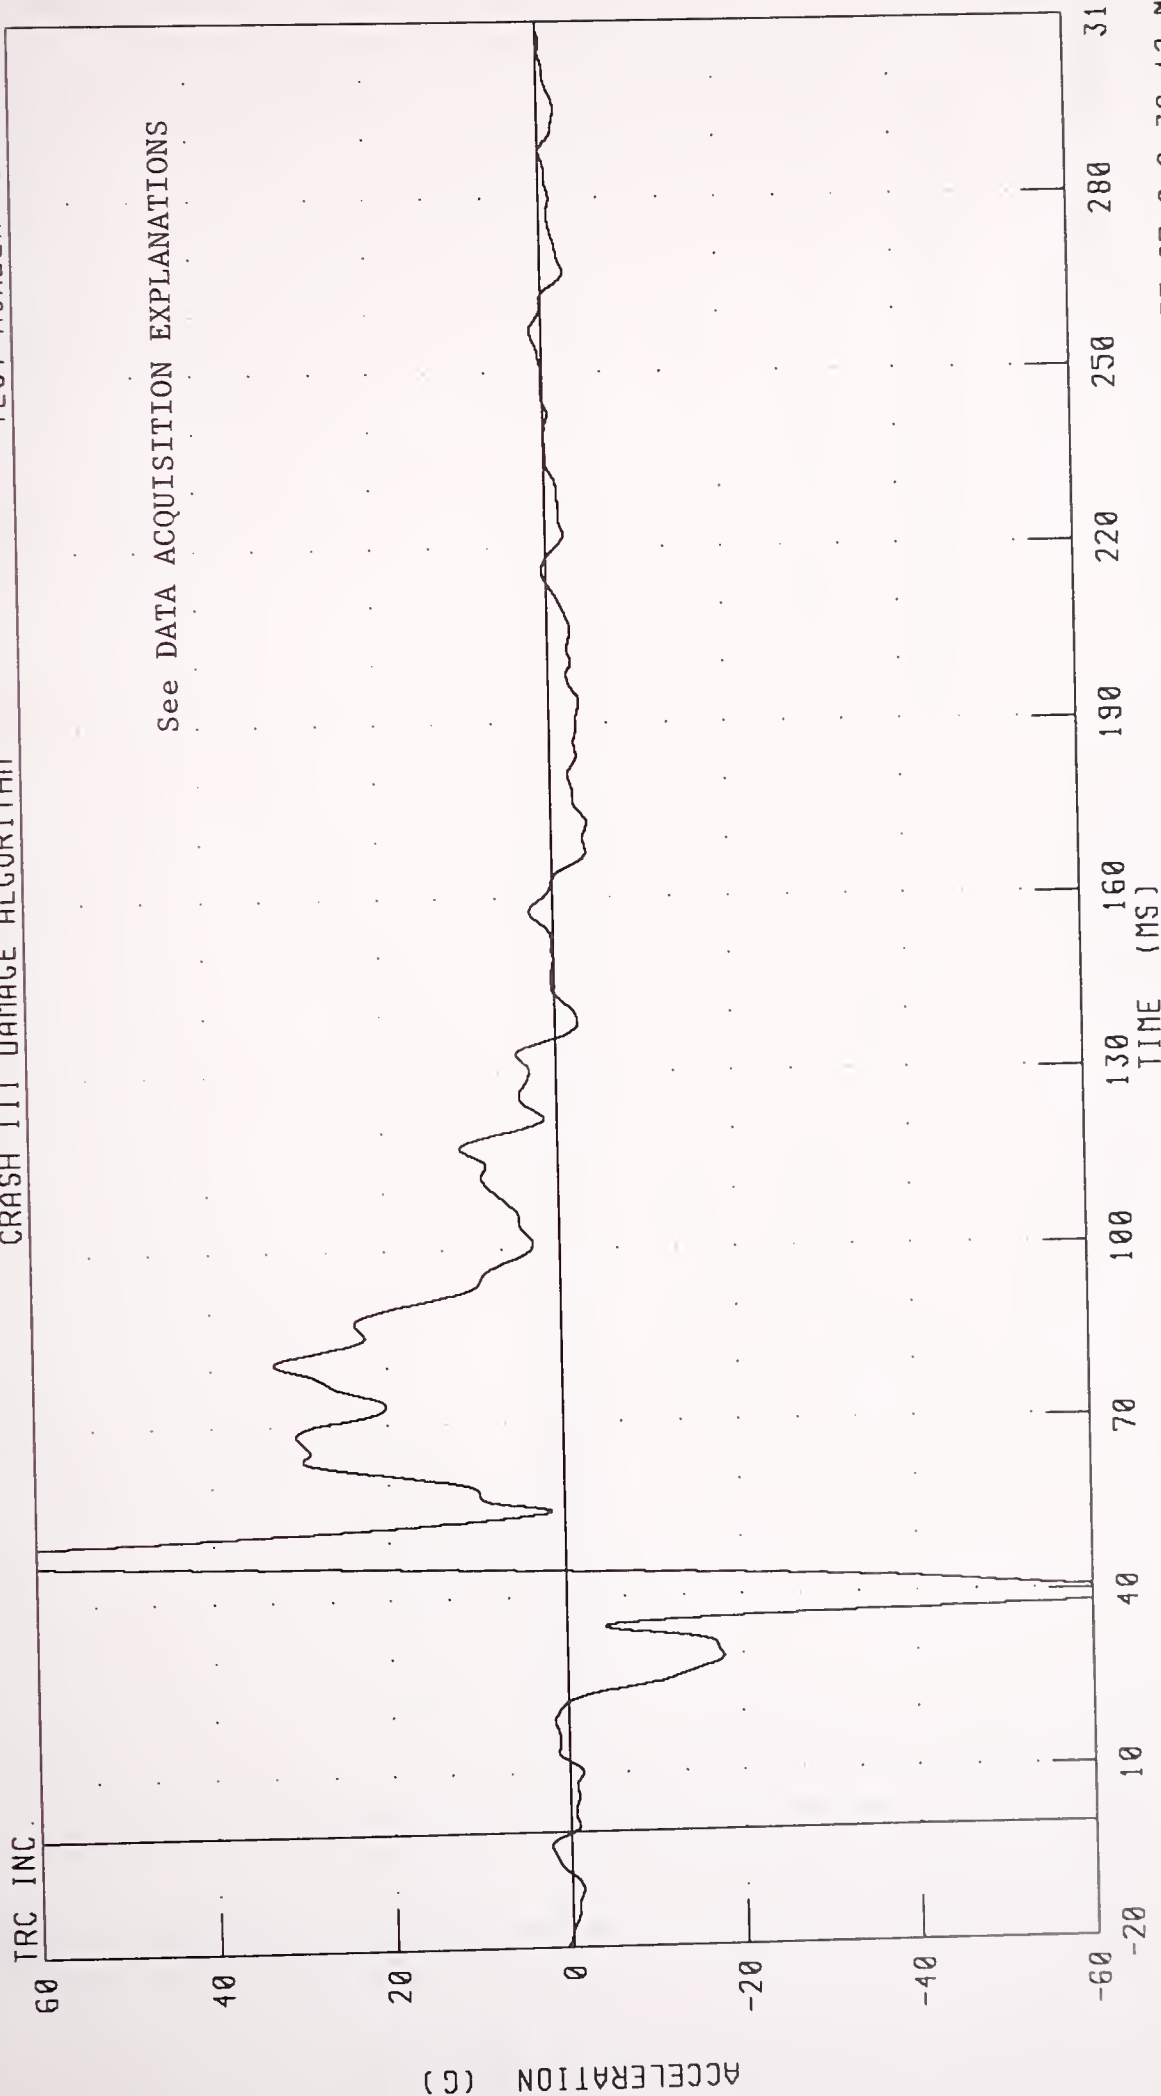
PEAK DATA: 93.35 G @ 48.32 MS; -75.97 G @ 39.12 MS

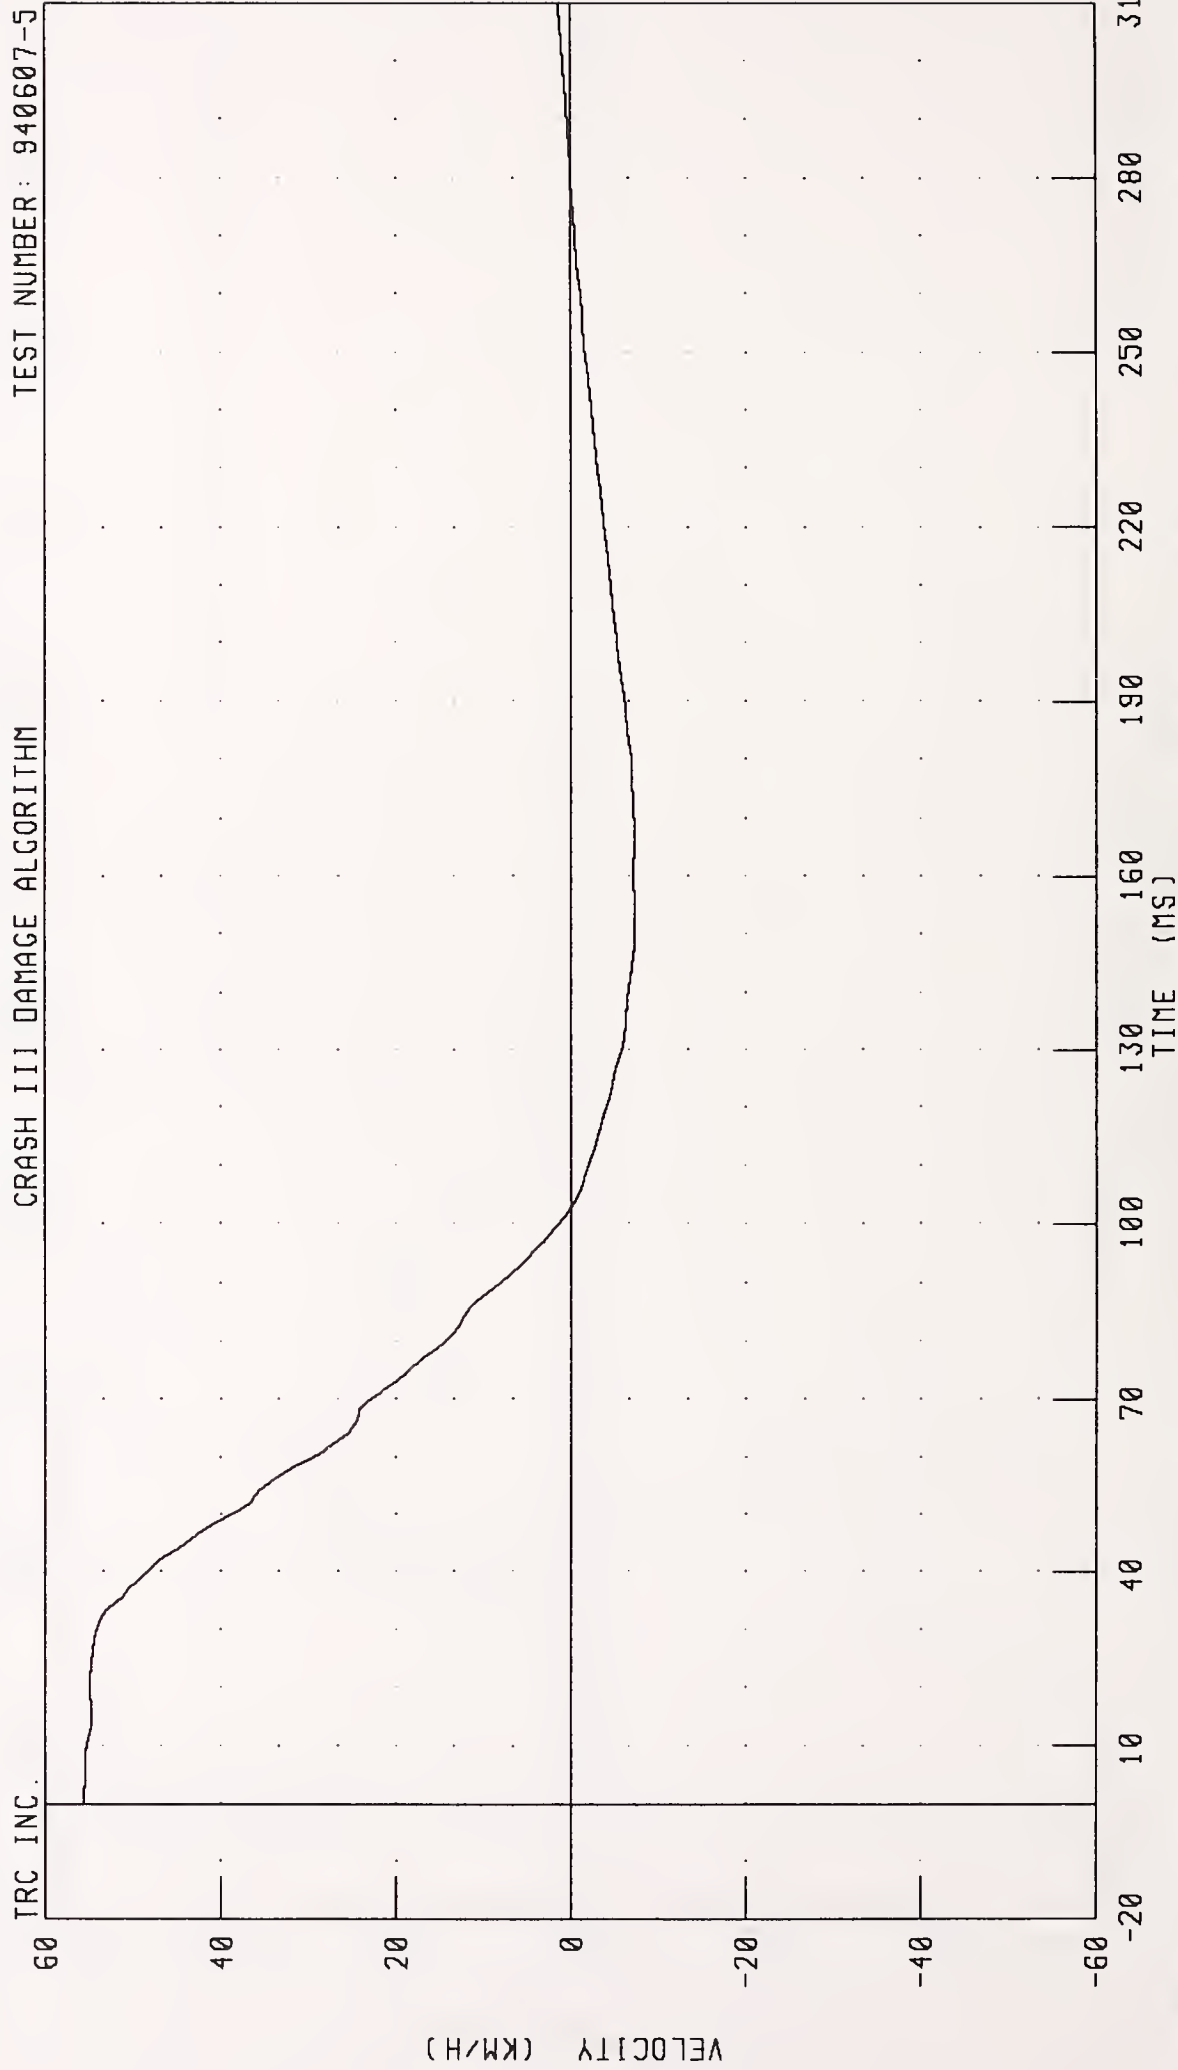
CHANNEL: LRSXV1 FILTER: CH. CLASS 180

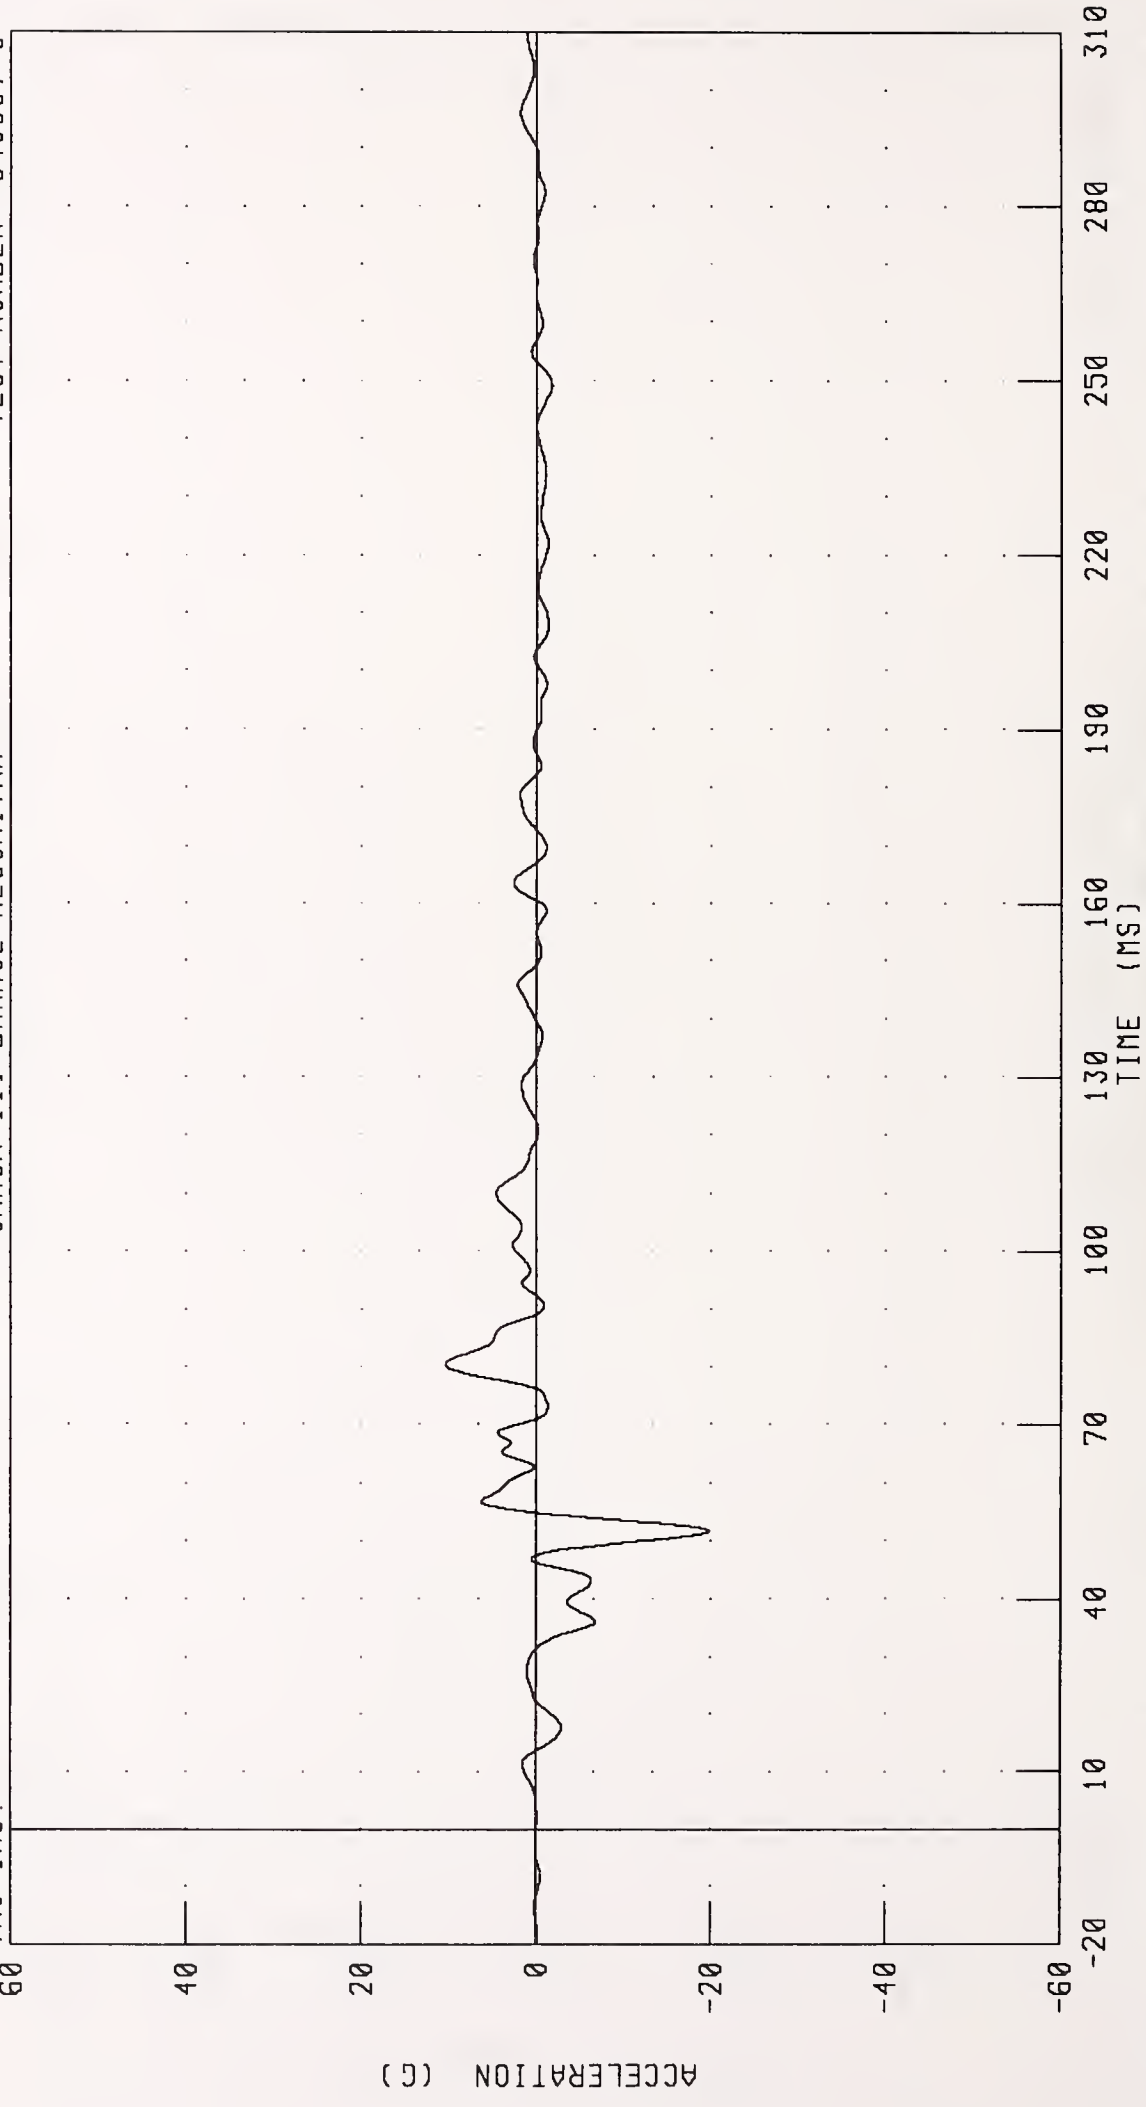
CHANNEL: LRSYG1 FILTER: CH. CLASS 60 PEAK DATA: 10.42 G @ 80.48 MS; -19.83 G @ 51.76 MS

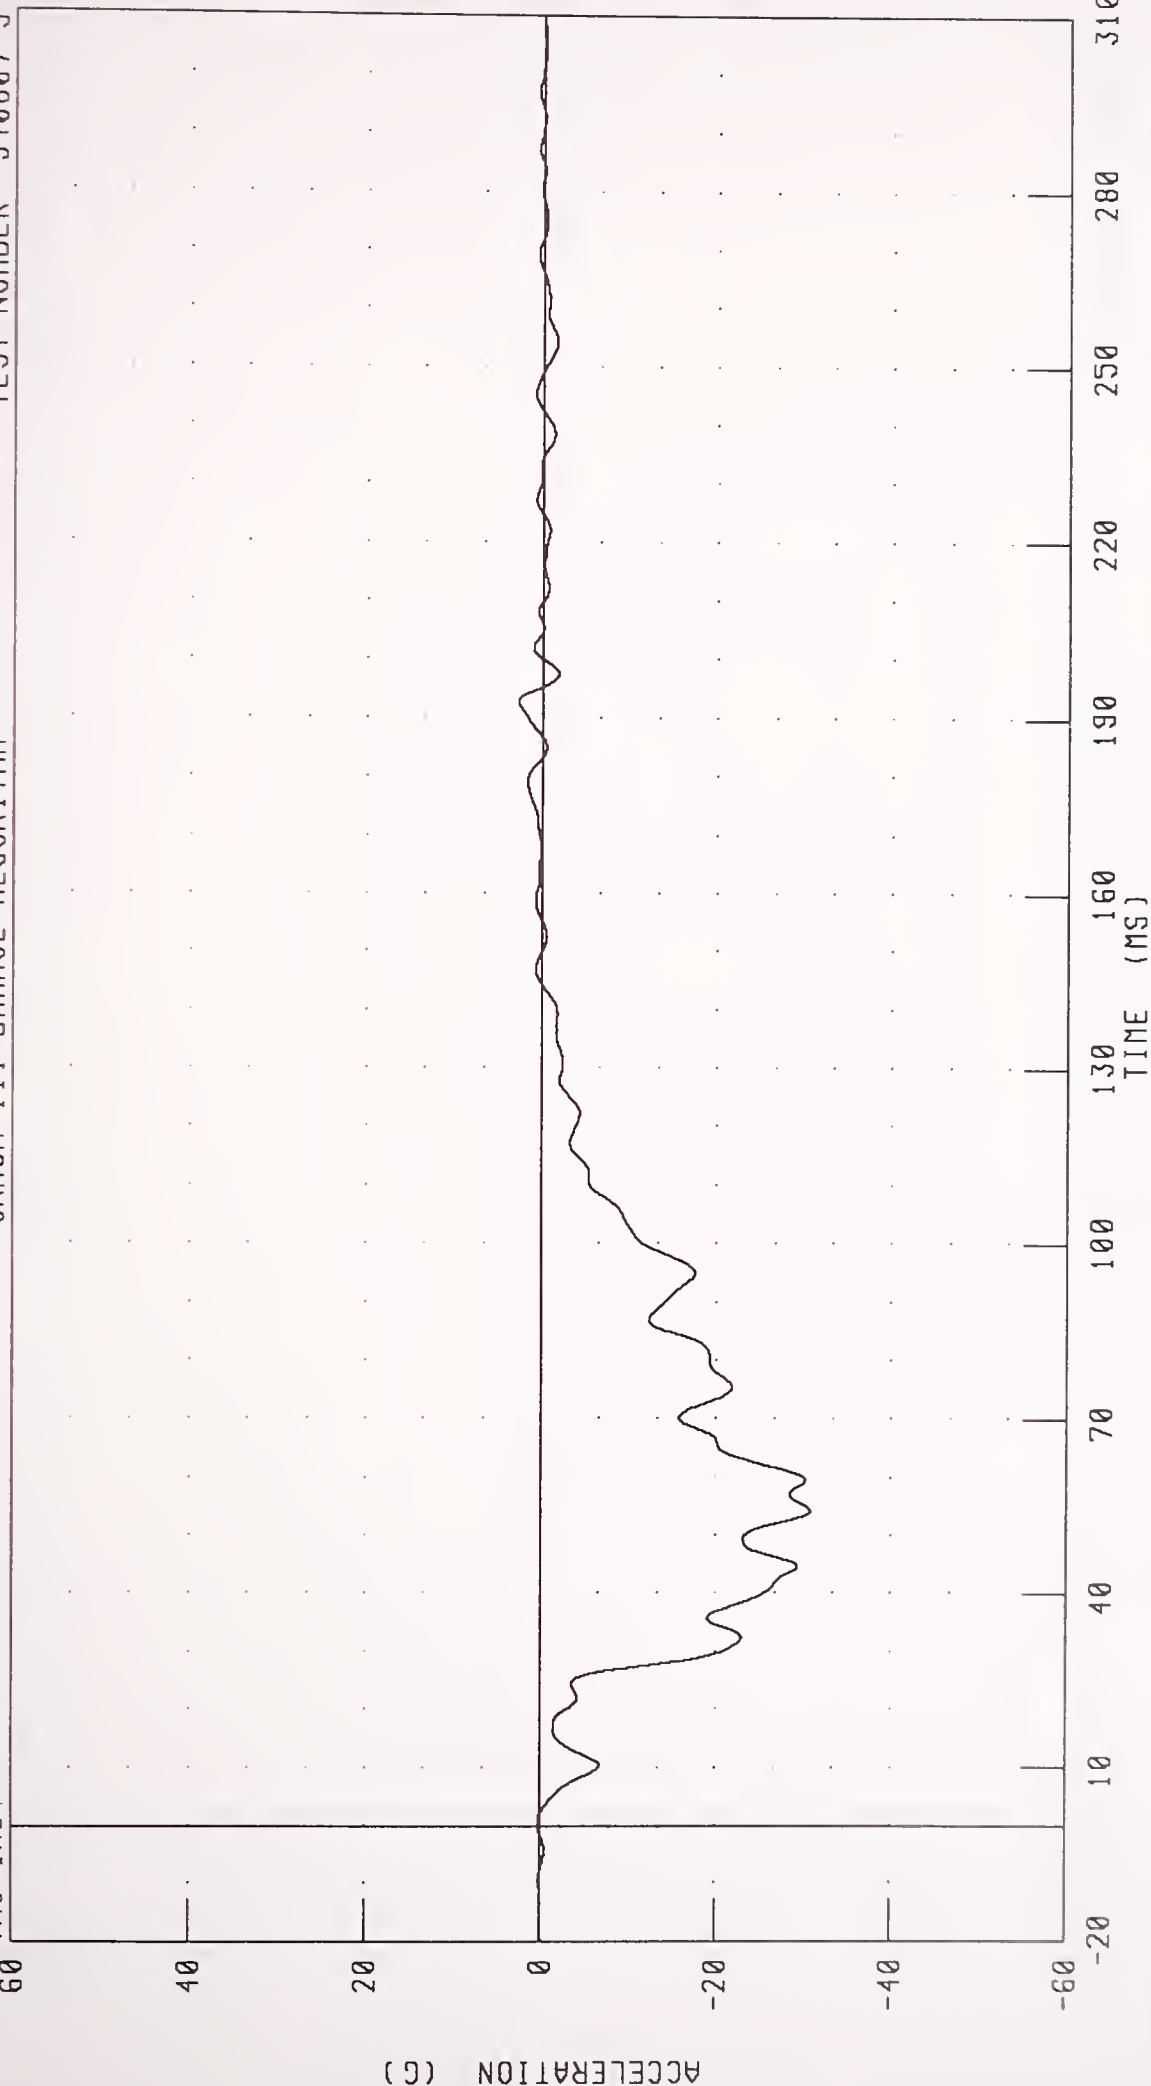
CHANNEL RRSXG1 FILTER: CH, CLASS 60

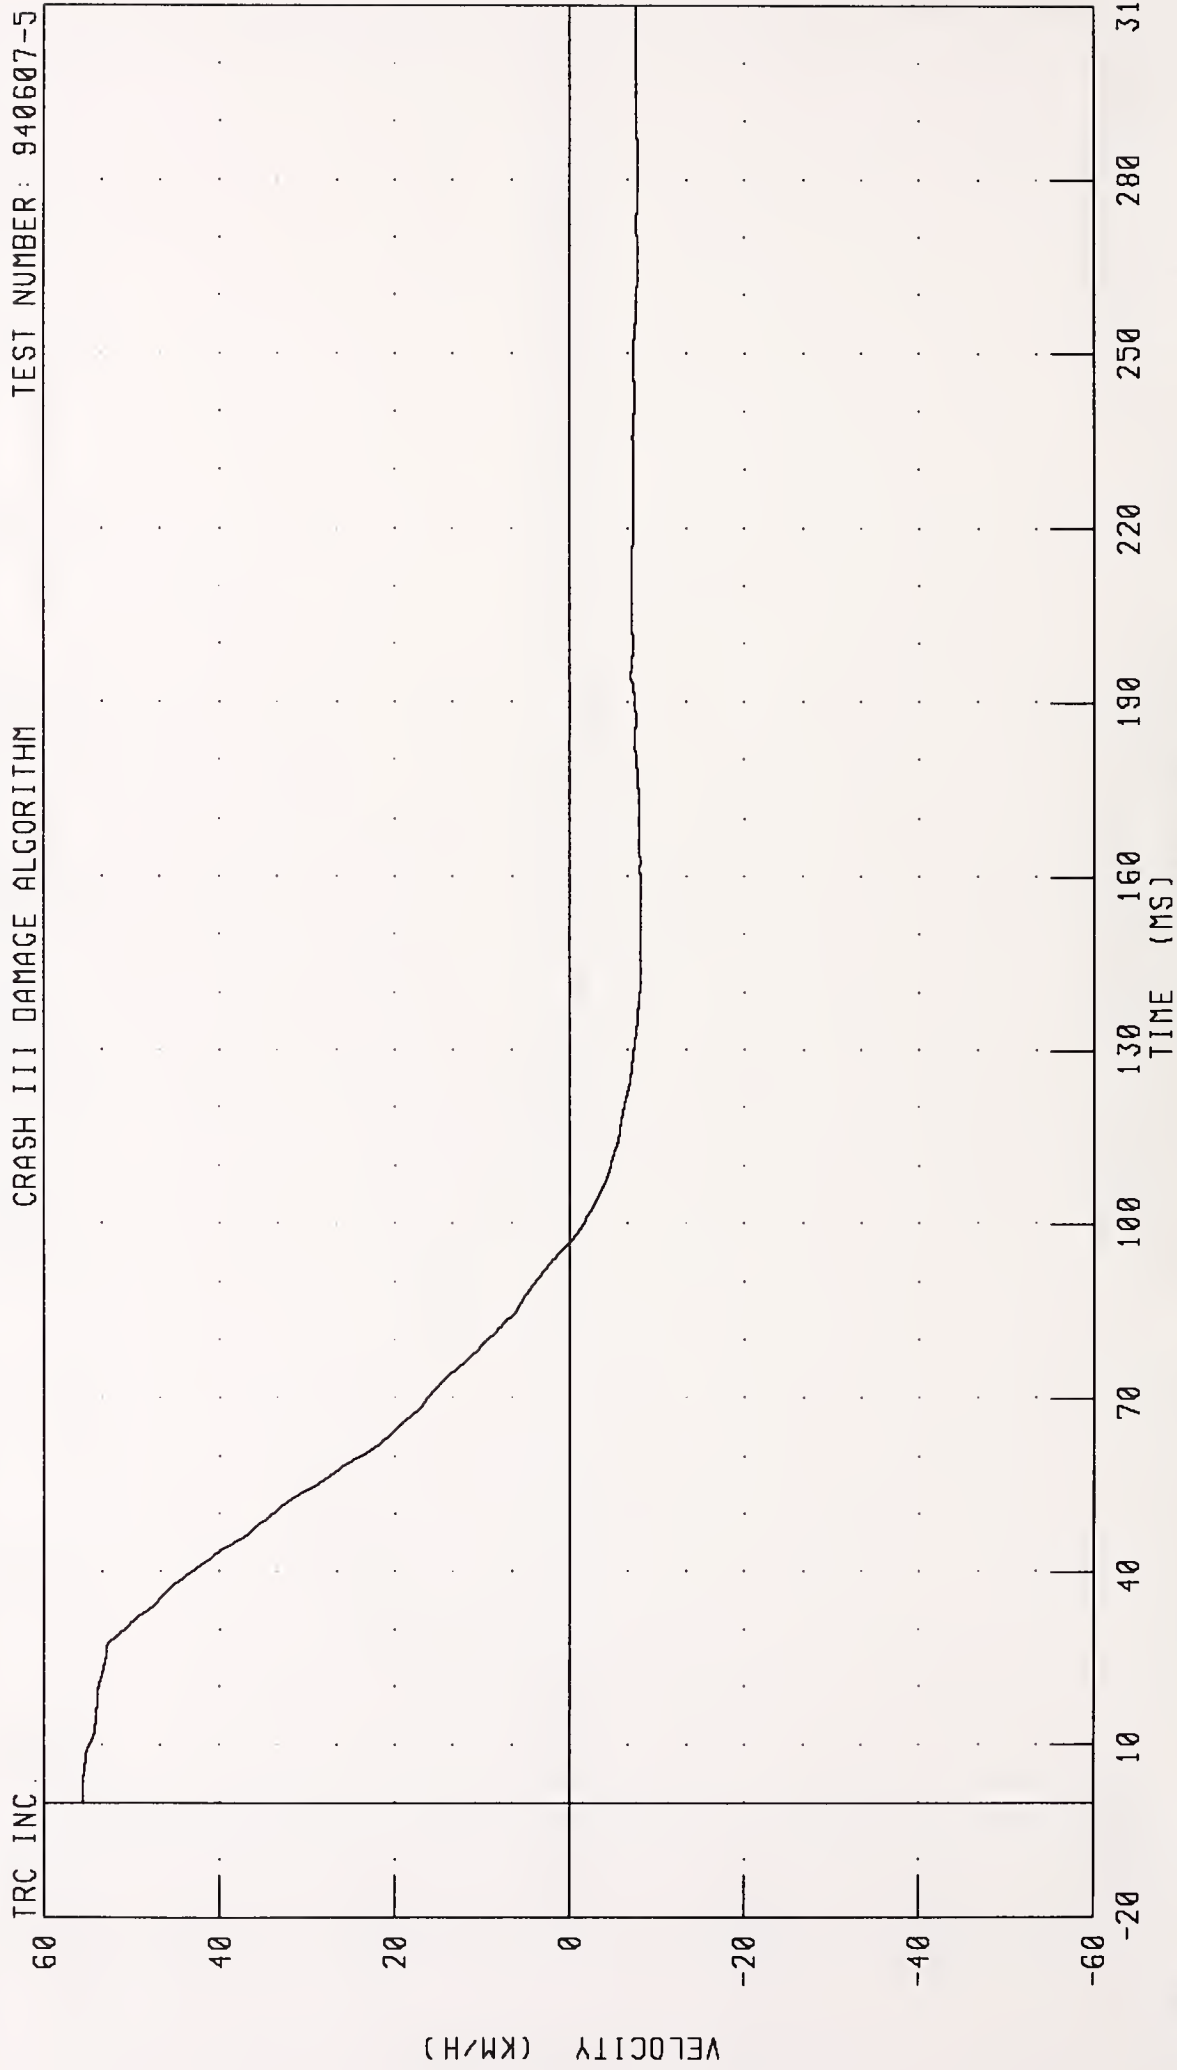
CHANNEL: RRSXV1 FILTER: CH. CLASS 180

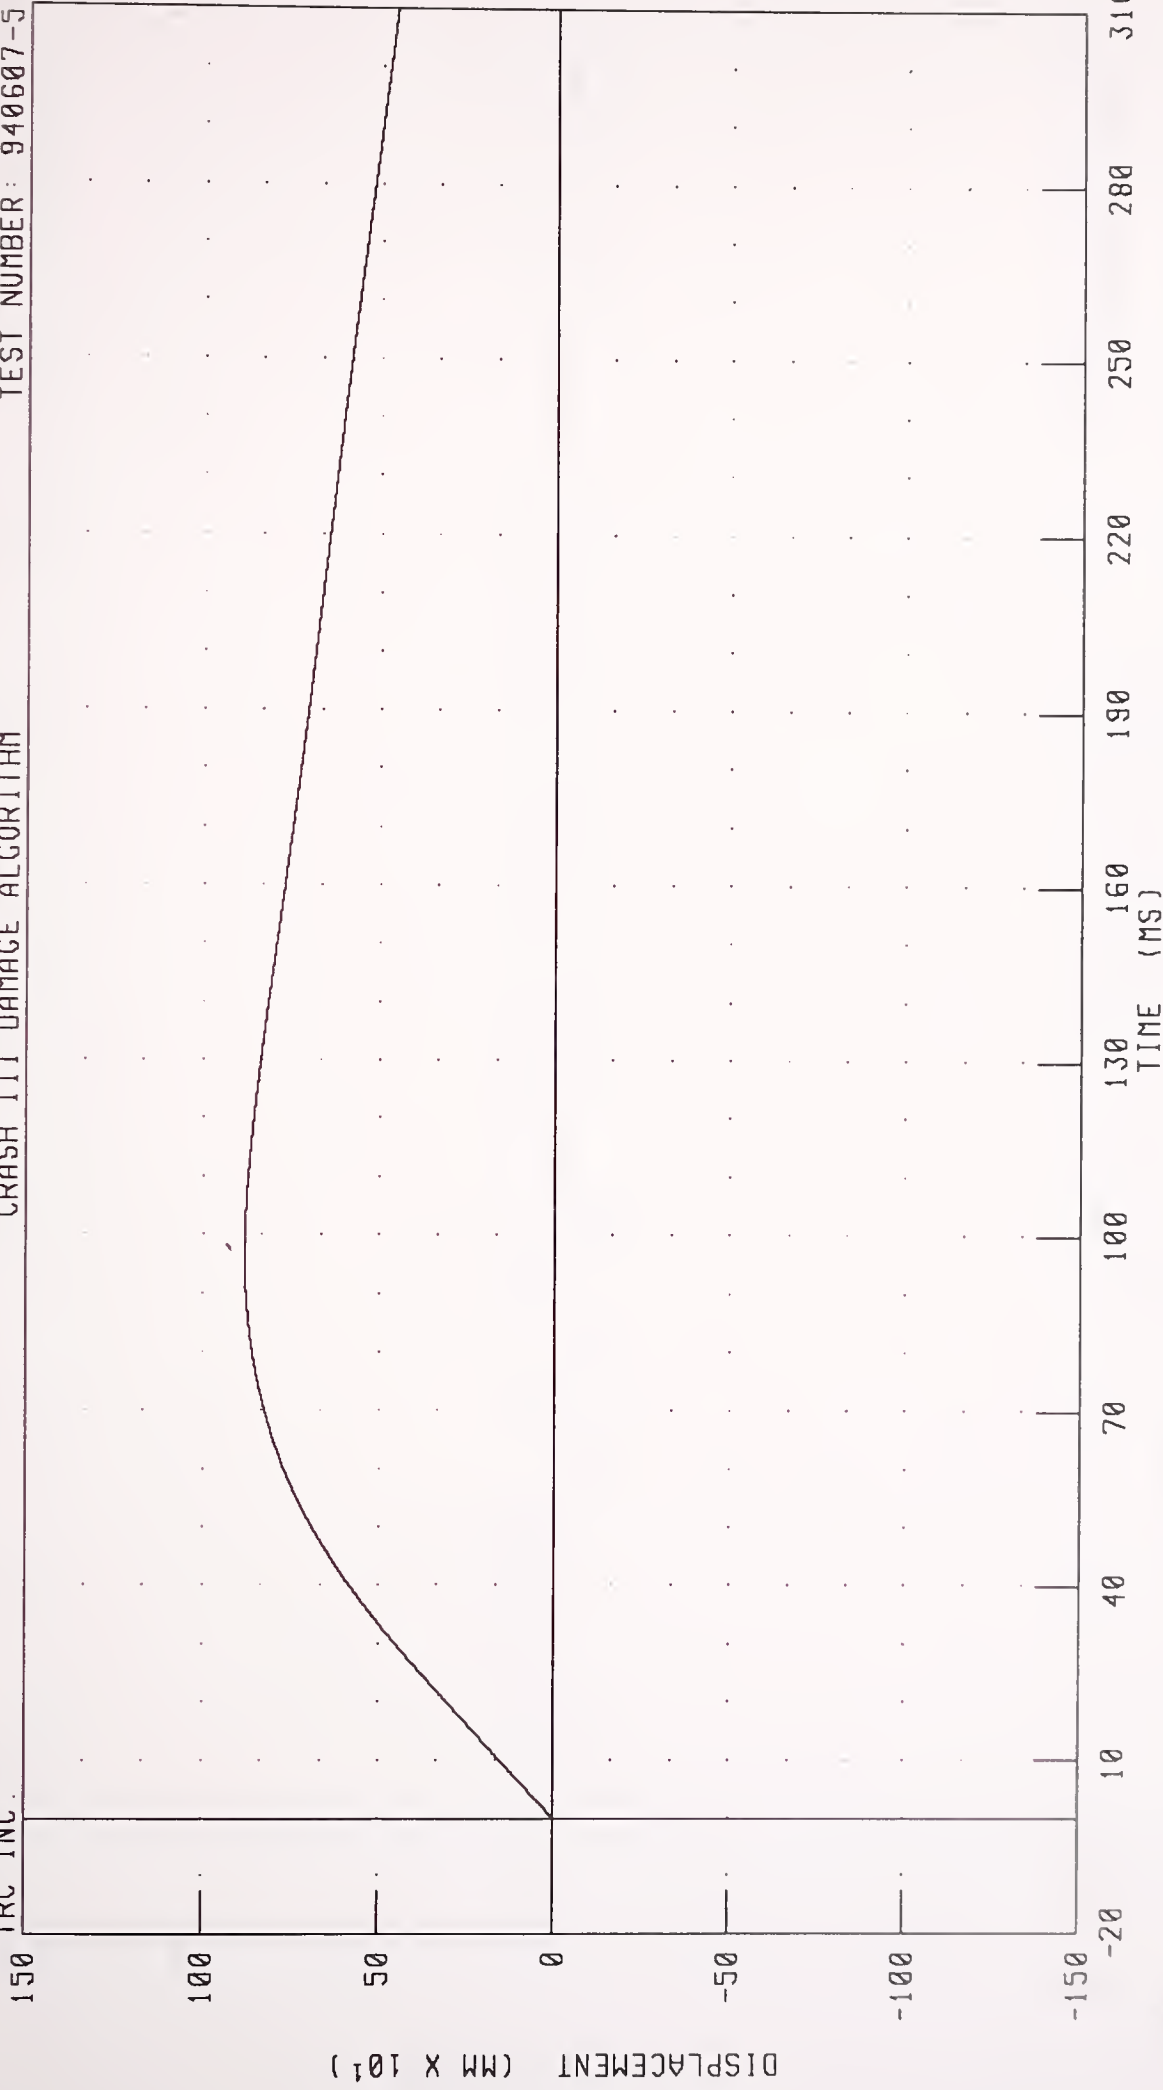
CHANNEL RRSXD1 FILTER CH. CLASS 180
